WIRING OF VCH1000/VCHE250 CABINET HEATER 5.5kW MOTOR.

DOC REF GB/TB/023/0207

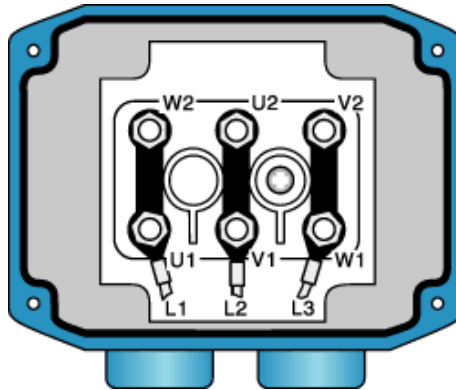
fig.1 - DELTA terminal link configuration

The 5.5kW motors used during the production of the Warm Air Cabinet **VCH1000/VCHE250** have changed. The new motor has a higher dual voltage of **400V/690V** and will only function correctly when wired in a **DELTA configuration**.

If the information displayed is **400V/690V**, then the terminal links **MUST BE WIRIED IN A DELTA CONFIGURATION** (see fig.1).

Although the running current remains at approximately 11.5 amps (free-standing heater), if this motor is wired in STAR by error, the actual motor speed would increase to between 1350 and 1400rpm.

As the motor is designed to be operated in delta, then operating continuously in star can cause damage to the motor. The voltage across, windings and magnetising current

torque capacity of the motors are reduced.

Operating at high loads as in cabinet heaters, will cause the slip of the motor to be increased dramatically and it may stall.

This will result in a dramatic increase in the power dissipated in the rotor. If the motor begins to stall, the starter will also suffer excess heating causing a motor failure.

When rewiring a replacement motor on this size cabinet heater, ensure the terminal links are correct to the sketch in fig.1 and adjust if necessary.

If the cabinet heater is identified as one included in the serial numbers shown below, en-

sure the terminal links are correct to the sketch in fig.1 and adjust if necessary.

If the cabinet heater displays any of the symptoms above check the terminal links are correct to the sketch in fig.1 and adjust if necessary.
