REPLACEMENT AACO VENTER MOTOR FOR THE UPA, UDSA, UDSB-D, LCSA, & ST-2 HEATERS (4 WIRE).

General information.

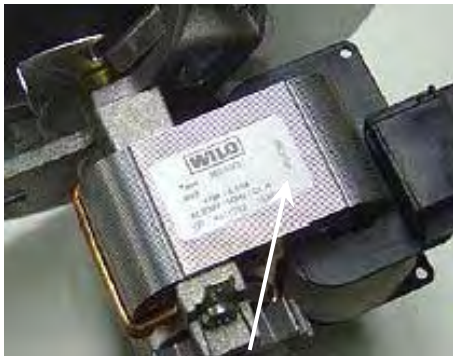
fig.1 - Original WSC Venter Motor

Venter motor for UDSA/UDSBD 025 - 030 & UPA 030 types WSC SP4511446-03 & EBM KM 405012 and UDSA/UDSBD 032-100/UPA 040-090/ST-2/SCA types WSC SP 4606-32 & EBM KM 405012 have been replaced by the

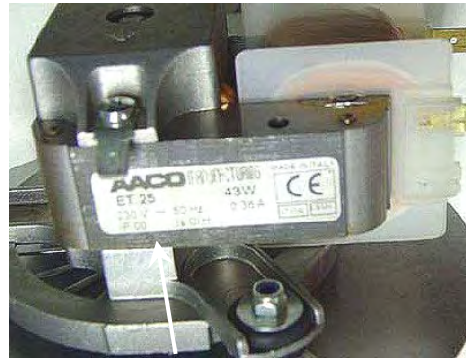
fig.2 - Replacement AACO Venter Motor

AACO 60.2.75M+C3.15 motor.

There are four wires to this motor, two of which are used for bi-direction. Care should be taken to use the correct cable colour. This technical bulletin describes the colour coding and cable termination to each comparable model.

8. Locate the relevant replacement venter motor.
9. Reattach the motor plate to the venter housing using the screws from step 5.
10. Using the 3mm allen key, reattach the impellor to the motor shaft, making sure the impellor is in the same position as the original and that the screw is tight.
